# Intelsat-29e Interference Mitigation Testing

## Interference Scenarios and Mitigation Techniques Enabled by the Intelsat Epic<sup>NG</sup> Class Satellites

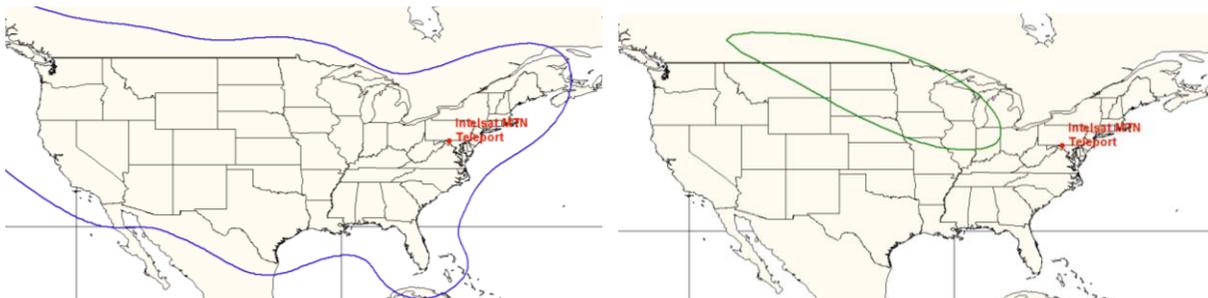
In a multi-spot satellite, the coverage area of each spot beam is typically significantly smaller than the area of a traditional, landmass-shaped, wide beam. Figure 1 contrasts the CONUS (contiguous U.S.) wide beam coverage of Galaxy-17, on the left, with the spot coverage of Beam K01 on IS-29e on the right. This difference in coverage areas leads to the first interference mitigation tool provided by Intelsat Epic<sup>NG</sup> satellites, namely out-of-beam rejection.

*Figure 1 – Wide Beam versus Spot Beam Coverage Areas*

The operational environment for this testing was User Beam K01 on IS-29e configured in loopback. I.e. a signal uplinked in the K01 coverage area was received by IS-29e, routed onboard via the digital payload, and transmitted back to earth in the Beam K01 downlink. Beam K01 is shown in the right hand side of Figure 1. The up and downlink frequencies were Ku-band.

The difference in coverage areas between a wide and a spot beam drastically restricts the locations from where an interferer can impact services. For the interference scenario described above and on the Galaxy-17 CONUS wide beam, an interferer could disrupt the friendly transmission from anywhere within CONUS.

When the same scenario is attempted on User Beam K01 on IS-29e, the interferer can be effective only if within the much smaller K01 coverage area. If the interferer is located outside of Beam K01, its signal will not be detected by the IS-29e satellite or will be received at a diminished level. When the interference source is located in Beam K01, other mitigation techniques are possible and are described later in this paper.

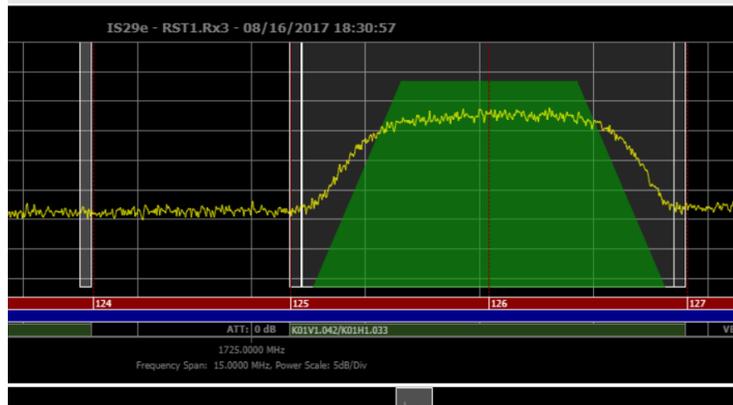
Figures 2 and 3 show, respectively, the uplink and downlink spectrum of this testing. IS-29e has an onboard spectrum monitoring system (SMS). Intelsat Epic<sup>NG</sup> satellites continually transmit their SMS data to Intelsat Operations for real time and archival uses. In Figure 2, the yellow line is the spectral power received at IS-29e from Beam K01. The green trapezoid in Figure 2 is an overlay from Intelsat's asset planning system and represents an approved and allocated carrier. The carrier shown is the remote-to-hub video carrier.

Figure 2 – Nominal Uplink Carrier Spectrum for Out-of-Beam Interferer Testing on IS-29e

Figure 3 shows the IS-29e Beam K01 downlink spectrum as received at the hub. Figures 2 and 3 were taken during nominal operations; the carrier was being properly received and the video quality from remote to hub was excellent.

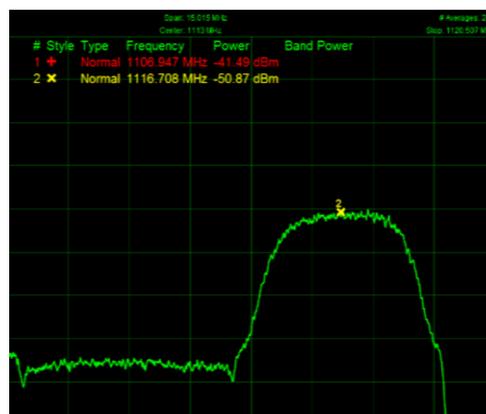
Figure 3 – Nominal Downlink Carrier Spectrum for Out-of-Beam Interferer Testing on IS-29e

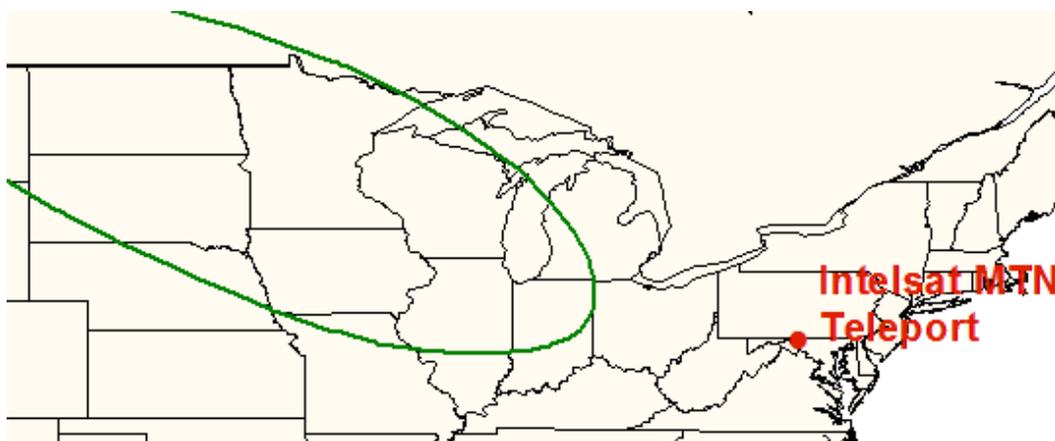
To demonstrate out-of-beam interference and mitigation, Intelsat’s Mountainside Teleport (MTN), located in Hagerstown, MD, transmitted an interferer that matched the friendly carrier. The locations of the MTN Teleport and the IS-29e Beam K01 (nominal beam edge) are shown in Figure 4.

Figure 4 – Mountainside Teleport and IS-29e Beam K01 Locations

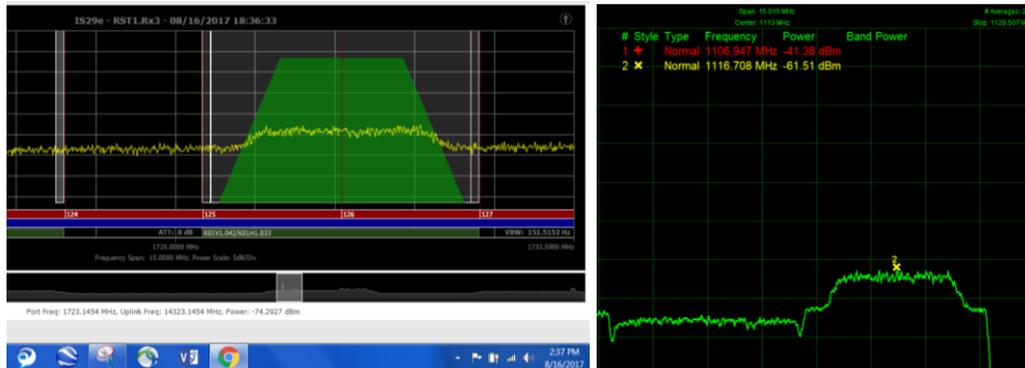
The MTN interferer matched the friendly carrier in size (symbol rate), modulation, and transmitted power level (EIRP). Since MTN is outside, but still close to, K01 coverage area, its transmitted signal was received at a much lower level than the friendly carrier. Figure 5 shows the uplink and downlink spectrums of the interfering carrier (the friendly carrier has been turned off). Due to the out-of-beam location of the interferer’s transmission, its received power spectral density level in the satellite is approximately 12 dB below that of the friendly carrier.

Figure 5 – Out-of-Beam Interferer Uplink & Downlink Spectrums on IS-29e

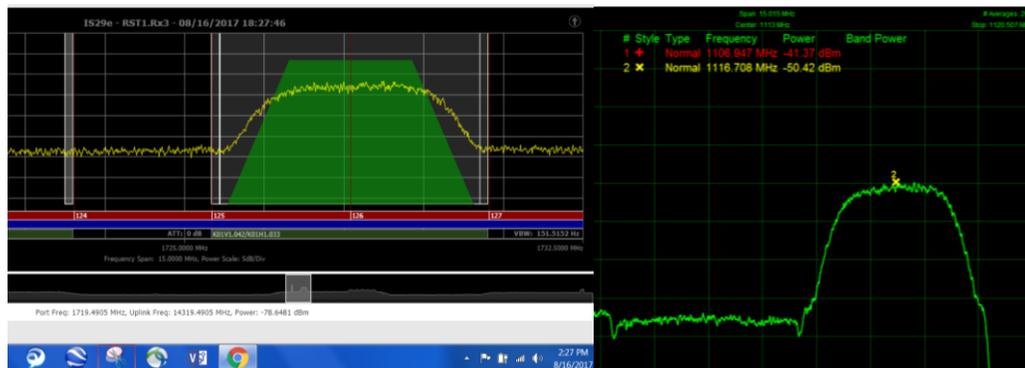
With both the friendly and interferer carriers transmitting, the uplink and downlink spectrums were as shown in Figure 6. Even with the transmission of an equal power interference signal, out-of-beam rejection by IS-29e was sufficient to enable excellent video reception at the hub. Received video quality was the same as with no interferer present.

Figure 6 – Simultaneous Friendly and Out-of-Beam Interferer Transmissions

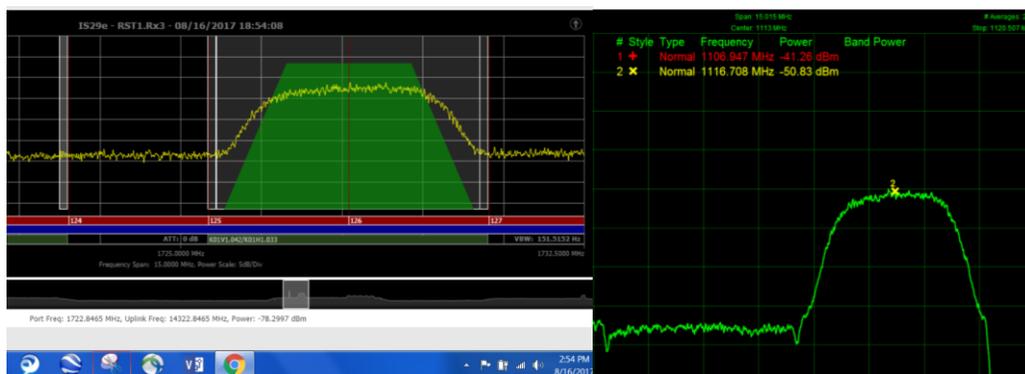
To create an in-beam interferer, we transmitted a matched carrier from the hub location. This carrier was separate from, and in addition to, the remote-to-hub video carrier. At the start of this test, the video carrier was as shown in Figure 7. This is identical to the start of the out-of-beam interferer testing, i.e. Figures 2 and 3. As before, in this mode, the video signal was properly received at the hub and video quality was excellent.

Figure 7 – Nominal Uplink & Downlink Spectrums for In-Beam Interferer Testing

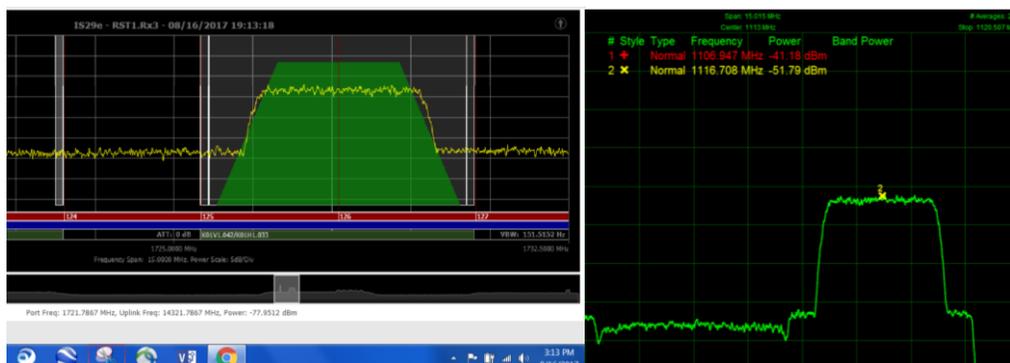
The interferer signal was then transmitted from the hub location. As in the previous test, the interfering carrier matched the friendly carrier in size (symbol rate), modulation, and transmitted power level (EIRP). Since the interferer transmitter was now located in the Beam K01 coverage area, its signal was received by the satellite at the same power level as the friendly carrier. Figure 8 shows Beam K01's uplink and downlink spectrums with just the interferer carrier present (the video, aka friendly, carrier has been turned off). Note that a different modulator type, one with a tighter carrier roll-off, generated the interfering carrier and thereby created a sharper carrier spectrum.

Figure 8 – In-Beam Interferer (only) Uplink & Downlink Spectrums

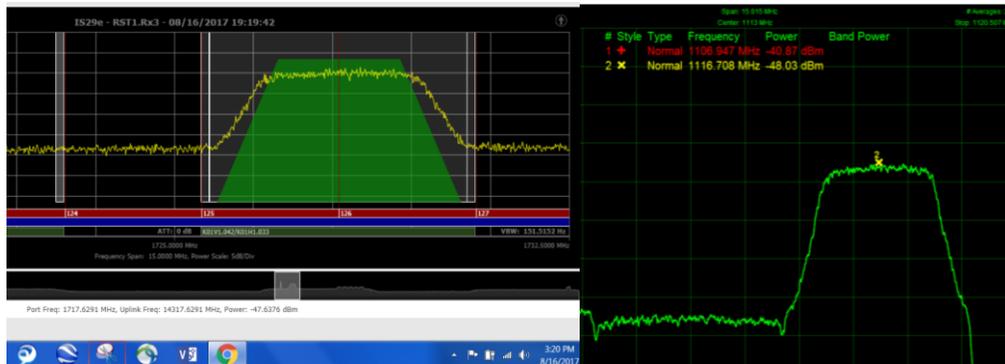
Transmission of friendly and interferer carriers simultaneously is shown in Figure 9. In this scenario, video reception at the hub was not possible. I.e. the friendly carrier was successfully jammed.

Figure 9 – Simultaneous Friendly and In-Beam Interferer Transmissions

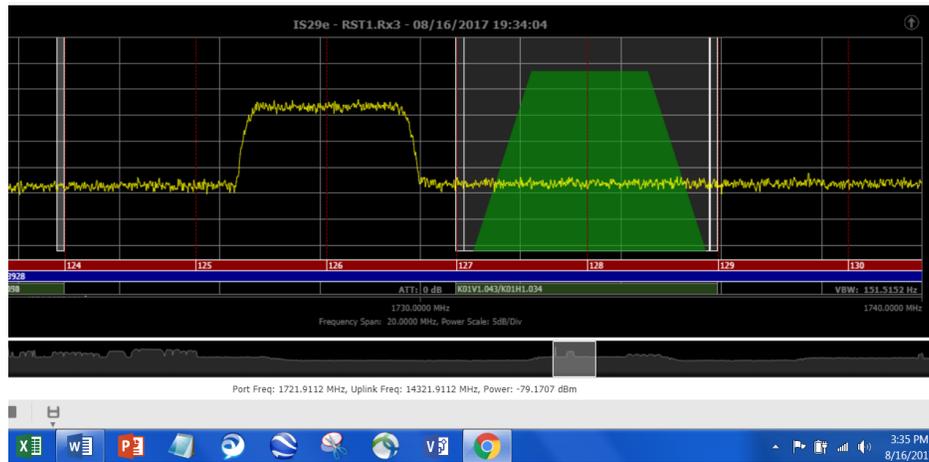
Figures 10 through 12 visualize the sequence of mitigation steps taken to counter the in-beam interferer. In Figure 10, satellite reconfiguration is underway. The video carrier’s uplink bandwidth has been re-allocated to avoid the interferer. The new allocation is the green trapezoid. Actual transmission of video carrier has not yet restarted.

Figure 10 –IS-29e Re-configuration to Terminate Interferer & Re-allocate Friendly Carrier

Transmission of the interfering carrier has been left as is but the uplink bandwidth it occupies has been deallocated on the satellite. As such, this uplink bandwidth is no longer routed onboard to a downlink path and, thereby, is terminated at the satellite. I.e. the interferer is no longer corrupting IS-29e’s transmissions back towards earth.

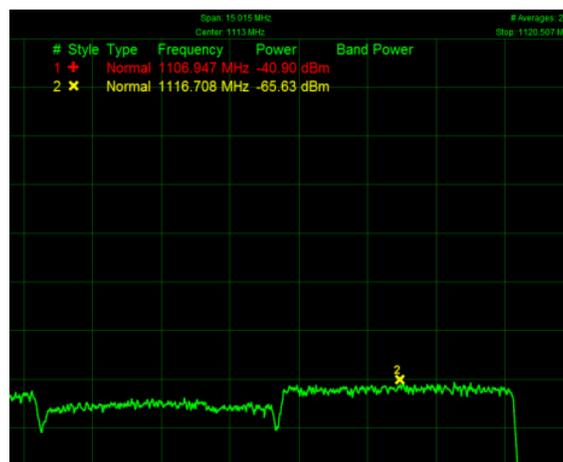
Figure 11 shows the IS-29e K01 downlink as received at the hub where the interferer has been blocked (aka is “notched out”). The friendly video transmission has not yet restarted.

Figure 11 – Beam K01 Downlink at Hub with Interferer Terminated

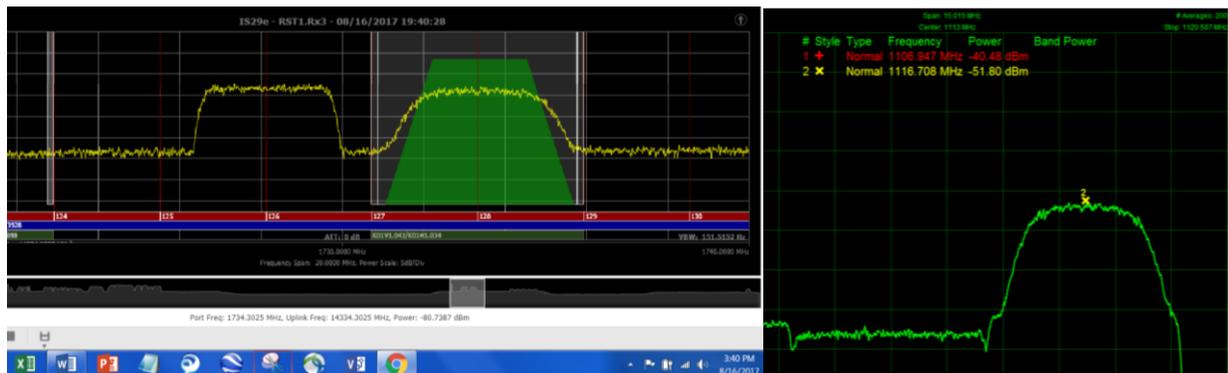
With the video transmission re-started, Figure 12 shows the two uplinked signals (left) and IS-29e’s single downlinked signal (right). At this point, successful video transmission has been re-established.

Figure 12 –IS-29e Reconfiguration to Terminate Interferer & Reallocate Friendly Carrier
