Intelsat Epic^{NG} High-throughput Satellite Platform Interference Mitigation Testing

Interference Scenarios and Mitigation Techniques
Enabled by the Intelsat Epic^{NG} Class Satellites

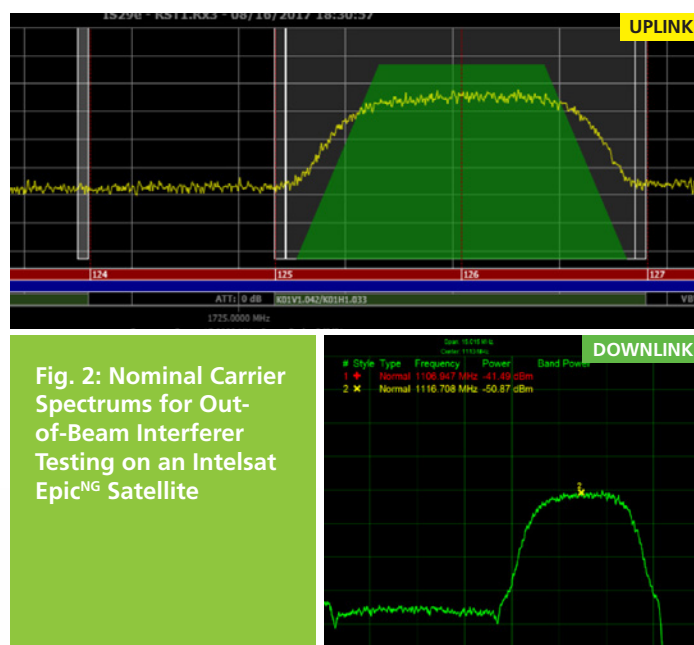
Fig. 2: Nominal Carrier Spectrums for Out-of-Beam Interferer Testing on an Intelsat Epic^{NG} Satellite

Figure 2 shows the uplink and downlink spectrum of this testing. The Intelsat Epic^{NG} satellite has an onboard spectrum monitoring system (SMS). Intelsat Epic^{NG} satellites continually transmit their SMS data to Intelsat Operations for real time and archival uses. In Figure 2, the yellow line is the spectral power received from the spot beam. The green trapezoid in Figure 2 is an overlay from Intelsat's asset planning system and represents an approved and allocated carrier. The carrier shown is the remote-to-hub video carrier.

Figure 2 shows the downlink spectrum as received at the hub. Figure 2 was taken during nominal operations; the carrier was being properly received and the video quality from remote to hub was excellent.

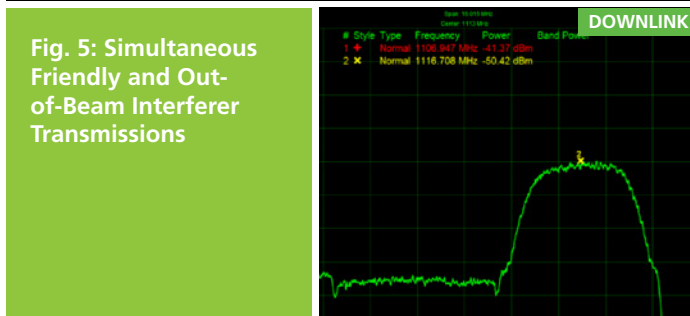
Fig. 5: Simultaneous Friendly and Out-of-Beam Interferer Transmissions

With both the friendly and interferer carriers transmitting, the uplink and downlink spectrums were as shown in Figure 5. Even with the transmission of an equal power interference signal, out-of-beam rejection was sufficient to enable excellent video reception at the hub. Received video quality was the same as with no interferer present.
